## Example AHU Report

### AHU layout

### HTM-03 Compliance checklist

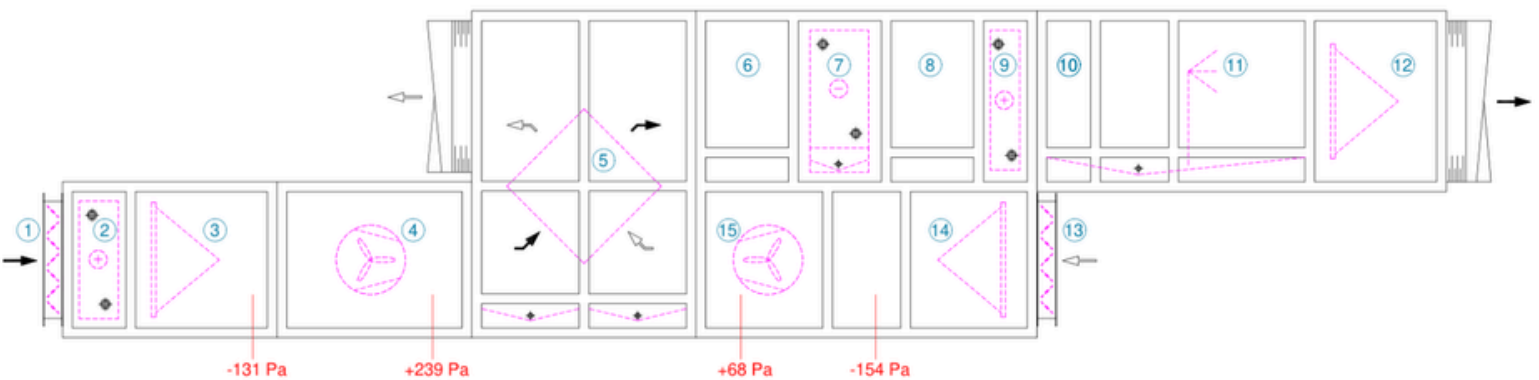
- 1) Fresh air intake damper (motorised)
- 2) Fog coil
- 3) Pre filters (bag)
- 4) Supply fan (motor out of airstream)
- 5) Plate heat exchanger
- 6) Access section
- 7) Chilled water coil
- 8) Access section
- 9) Main LPHW coil
- 10) Access section
- 11) Decommissioned humidifier
- 12) Secondary filters (bag)
- 13) Return air damper (motorised)
- 14) Extract filters (bag)
- 15) Extract fan
