## Example AHU Report

### AHU layout

### HTM-03 Compliance checklist

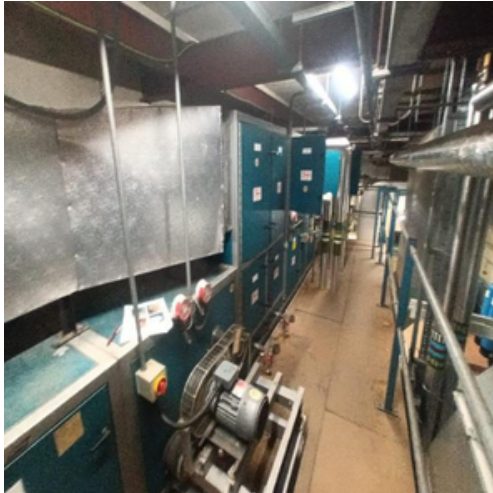
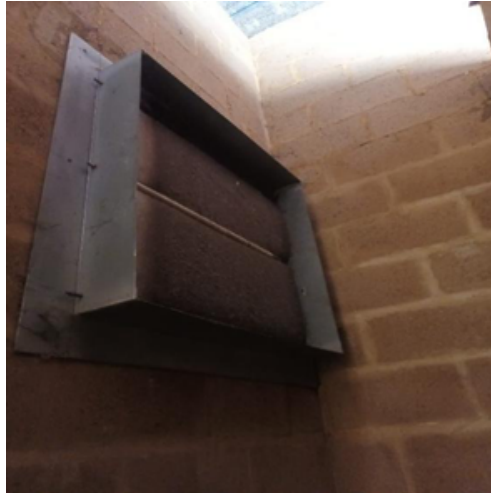
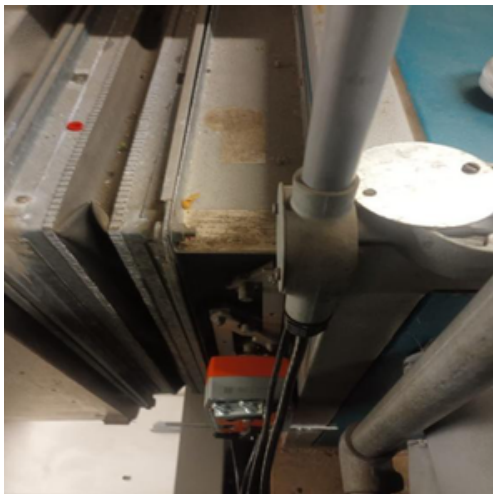
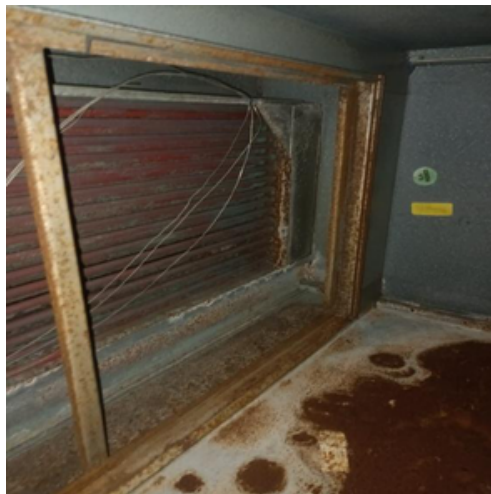
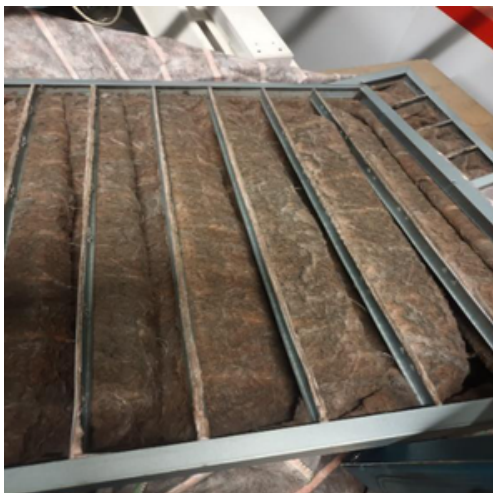
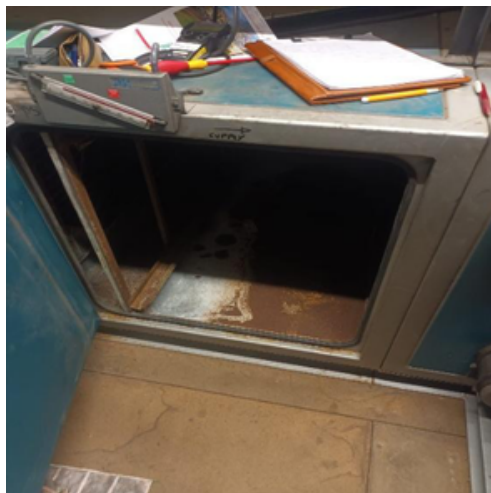
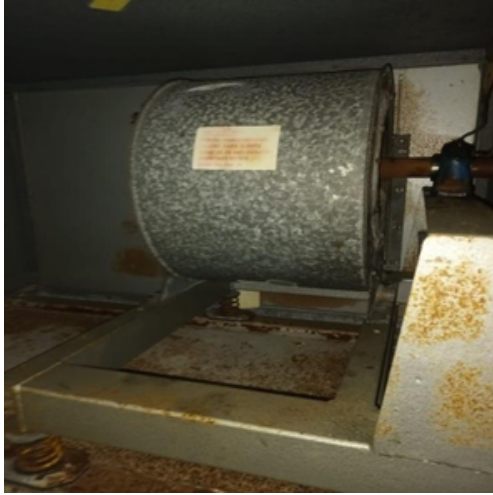
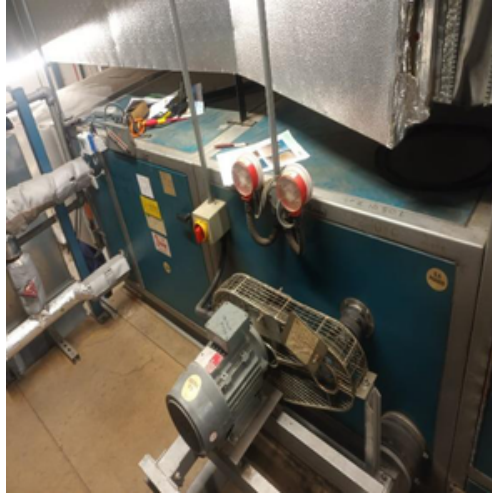
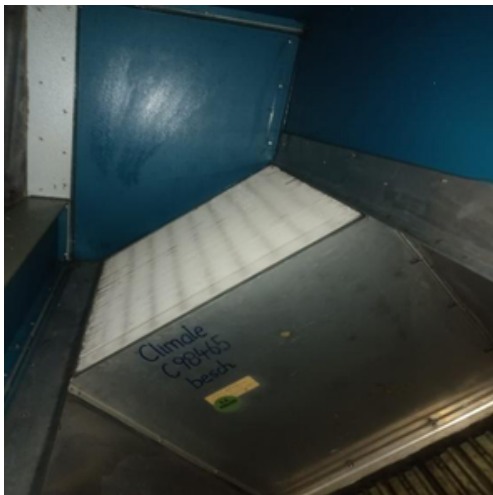
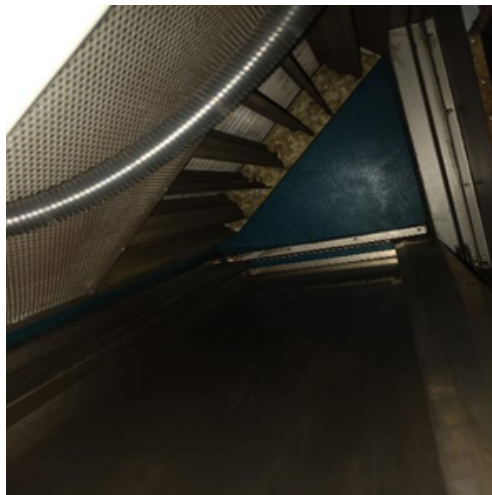
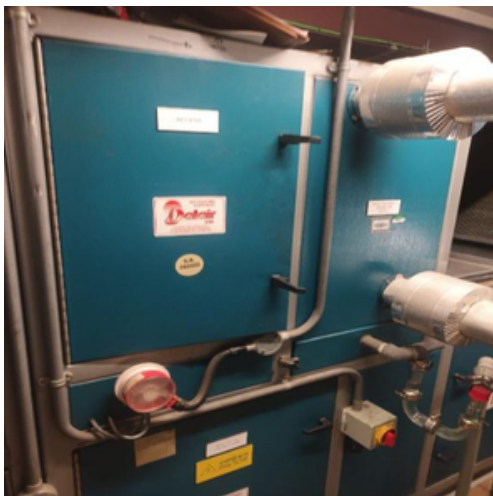
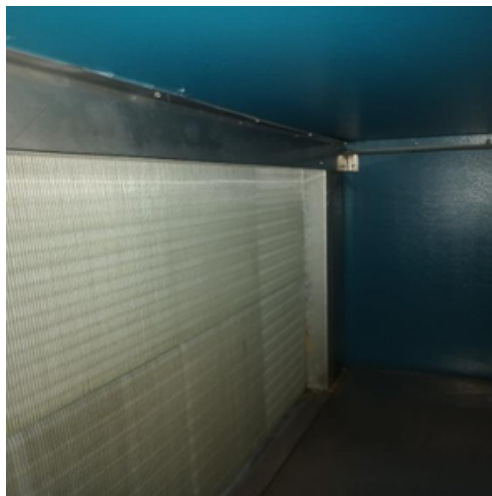
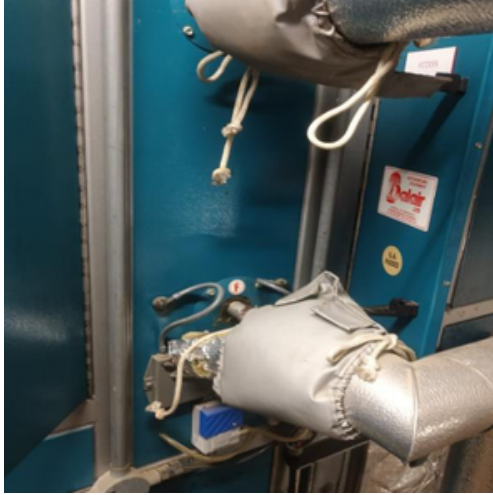
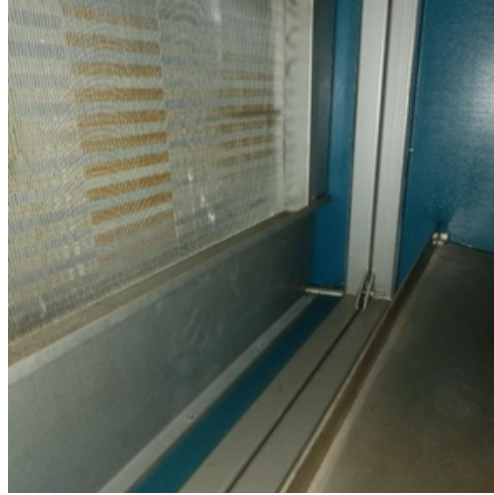
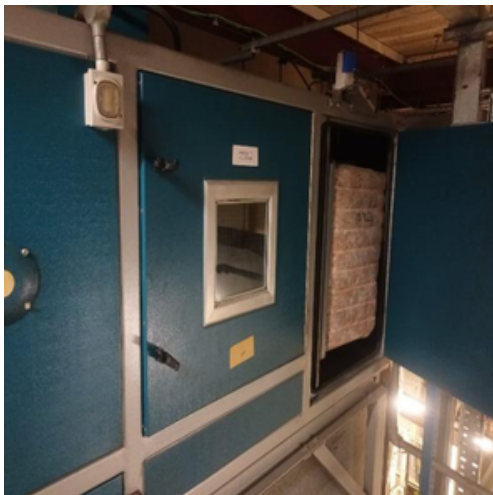
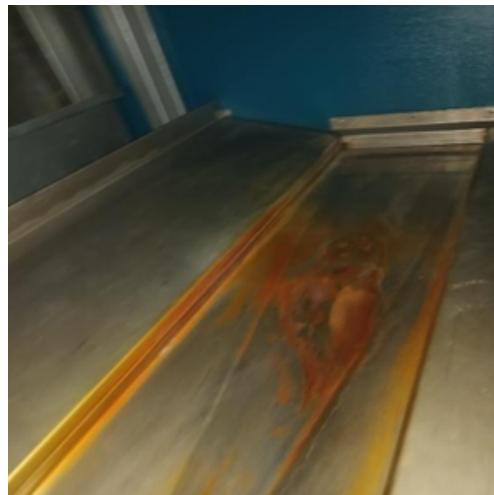
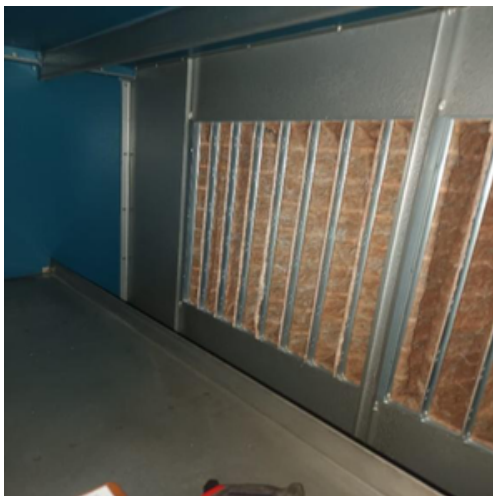
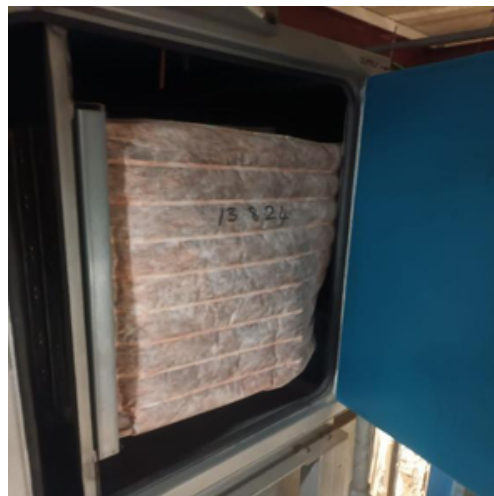
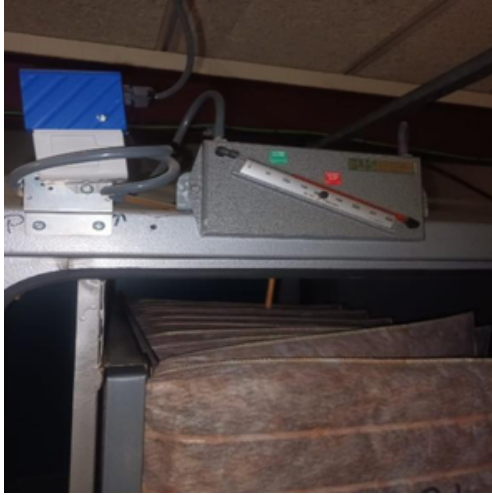
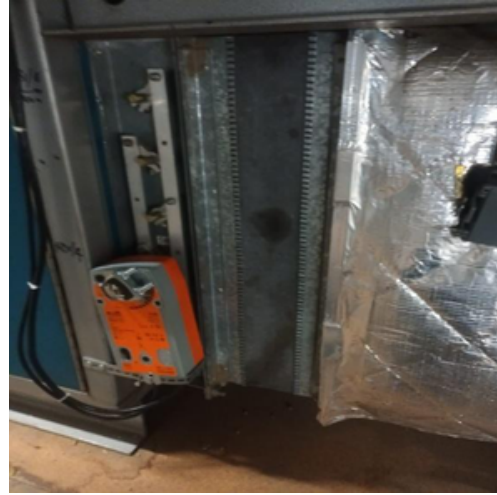
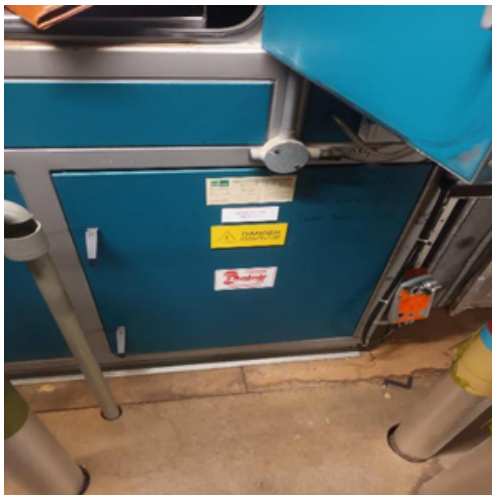
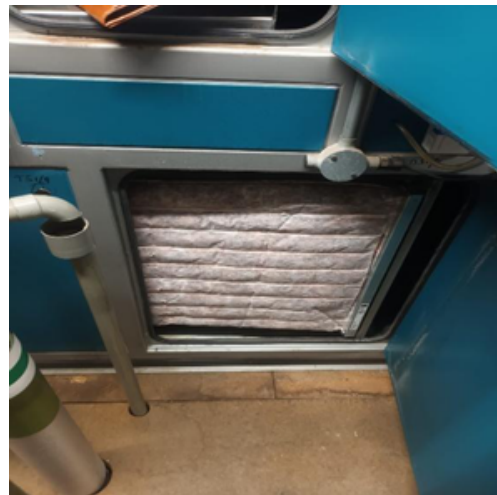
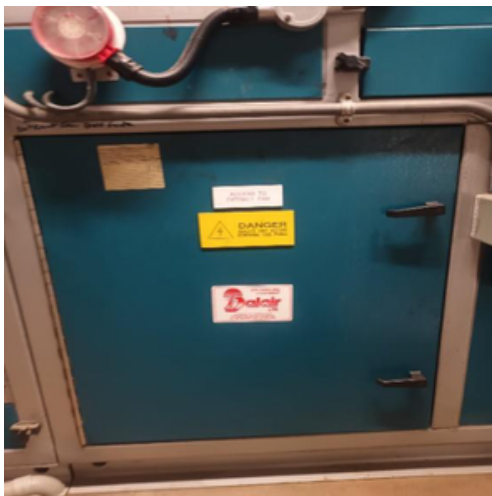
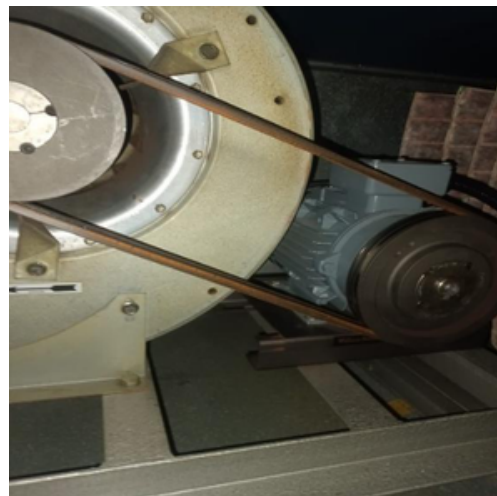
## Photos

| 28 | Is the intake section including fog coil clean? | CORROSION PRESENT IN FOG COIL & PRE FILTER SECTIONS. | N |
| 36 | Are the heating matrices clean for each heater battery? | FOG COIL APPEARS TO BE IN POOR CONDITION. | N |

- NO INTERNAL BULKHEAD LIGHTS OR PORTHOLES FOR EXTERNAL VIEWING IN FAN, ACCESS & FILTER SECTIONS.
- SHARED INTAKE PLENUM WITH HEAVILY SOILED G3 MEDIA FILTER FITTED TO DUCT INLET.
- NOTICABLE CORROSION FOUND IN THE INTAKE SECTIONS OF THE AHU (SEE PHOTOS ABOVE).
- INCLINE FLUID MANOMETERS FITTED TO FILTER SECTIONS.
