## Overview

## Rapid Response EC Fan Replacement

# Turnkey Frost Coil Replacement

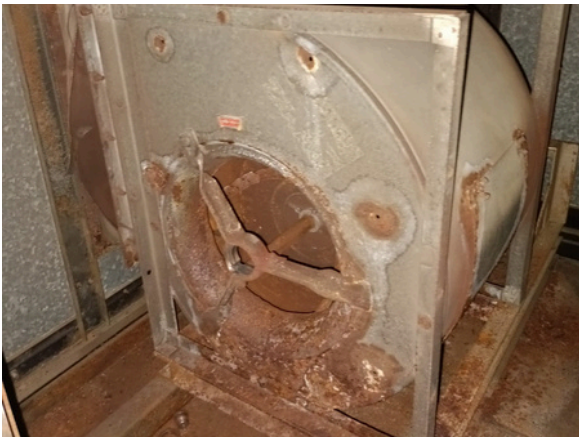
### Before Upgrade

Following the failure of a belt-driven fan within a critical ventilation system, AHS Specialist Services were contacted to provide an urgent replacement solution.

Following a site assessment, we designed a replacement arrangement using a high-efficiency EC fan, removing the existing belt-driven fan and motor assembly and modifying the AHU fan section to suit the new configuration. The works included new stainless-steel flooring, a replacement access door, local speed control, electrical modifications, and installation of the new EC fan.

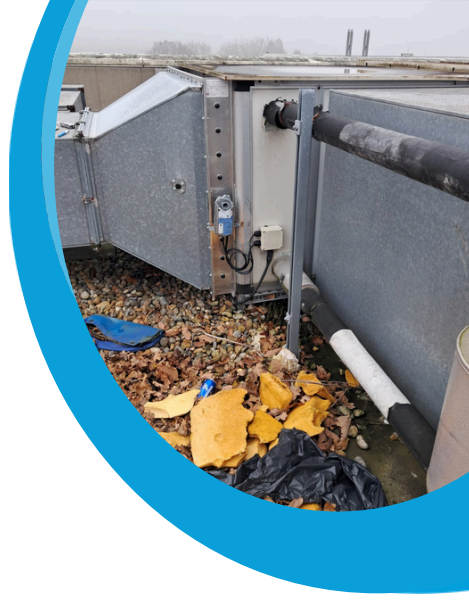
Before Upgrade

Following the failure of a frost coil serving a roof-mounted AHU, AHS Specialist Services were engaged to provide a complete turnkey replacement solution. The existing coil had failed due to freezing during a period of cold weather, requiring replacement to restore the AHU to operation.

Following an initial technical survey, AHS Specialist Services managed the project from measurement and manufacture through to installation and recommissioning. The works included isolation and disconnection of pipework, removal of the existing coil, modification of the AHU casework to suit the new arrangement, installation of the replacement frost coil, reconnection of associated pipework, and reinstatement of insulation.

- Technical survey and measurement of replacement coil
- Manufacture of replacement frost coil
- Modification of existing AHU casework
- Removal of failed coil
- Installation and reconnection of replacement coil
- Reinstatement of associated insulation
- Turnkey delivery from survey through to installation
